# INCIDENT INVOLVING LOSS OF A 37 GBq AMERICIUM 241 SOURCE FROM A RADIATION GAUGE

A.J.Melbourne  
Radiation Safety Section, Health Department Victoria.

This paper describes an incident reported to the Radiation Safety Section on 31 July 1986 wherein a radioactive source was found to be missing from the source housing of a radiation gauge used at a steel mill in Hastings, Victoria.

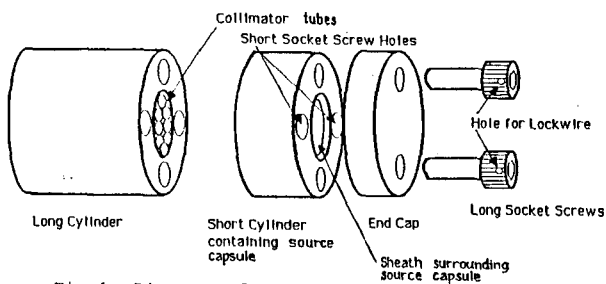
Fig.1 Diagram of Source Housing

The source was Americium 241 of activity 37 GBq, and was incorporated in a Reuter-Stokes Safety-Ray Type RSS-811 gauge (see Fig.1). It was used in one of six such gauges to detect the presence of steel slabs being rolled into sheet steel in the hot strip mill. Three were operational and three were installed as back-up devices which could be switched in should a fault develop during a rolling period. The source housings were made from stainless steel and were mounted in a comparatively inaccessible position between rollers under the hot strip mill. The radiation beam was directed upwards at an angle (see Fig.2). Below the source housings was a drop of approximately 6 metres to the flume system used to wash iron oxide scale from the mill area to collection pits.

The gauges on the hot strip mill are subject to wide ranges of temperature (the steel slabs on the mill are at 1100°C) and considerable vibration. It was considered that this, along with inadequate maintenance procedures and the design of the gauges, led to the screws loosening over a period of time and the source assembly eventually falling apart.

The design of the gauge was considered inadequate in that the source capsule was held in the source assembly only by the two long screws through the end cap. Whilst these had also been held by a lockwire with a lead seal, this wire had rusted through and disintegrated. It was considered that the design of the device should have been better considering the extremes of temperature and vibration and the configuration of the gauge in the hot strip mill.

- a) Each gauge to be removed from installation and inspected in detail in the workshop, with the following work to be carried out:
  - i) All source assembly screws examined and tightened to a torque of 8 Nt.m. Loctite 622 or equivalent to be used to ensure that they do not loosen. (It was noted that all screws were able to be tightened by at least a half turn, even a unit which had not been used but was as supplied by Reuter-Stokes).
  - ii) Rewire screw heads with MP35N or equivalent wire and seal.
  - iii) Inscribe serial numbers into body of assembly.
  - iv) Replace screws on beam window with stainless steel screws and MP35N wire or equivalent.

Source assembly then to be bolted to frame mounting at correct torque setting; bolts to be wired with MP35N wire or equivalent.

- b) Prior to each start-up of a rolling process, a physical check of frame and source assembly bolts to be carried out.
- c) For each sensor or out of calibration alarm, a physical check to be made to ensure that the source assembly is intact (to be logged).
- d) Torque on frame mounting bolts to be checked every 3 months.
- e) Torque of source assembly screws to be checked, and screws rewired, every 12 months.
- f) Mounting and removal access to the source assembly to be made simpler to allow for ease of removal for thorough inspection.
- g) A maintenance-free source holder to be designed and plans to be forwarded to the Health Department for approval; the design to allow source insertion from the top of the assembly and to negate the need for any assembly screws in the lower section.
