Radiological Hazards from Deposits of Tin-Smelting Slag and the Problems of Site Clearance and Disposal

J C Gilmore and R G Jackson

AEA Technology

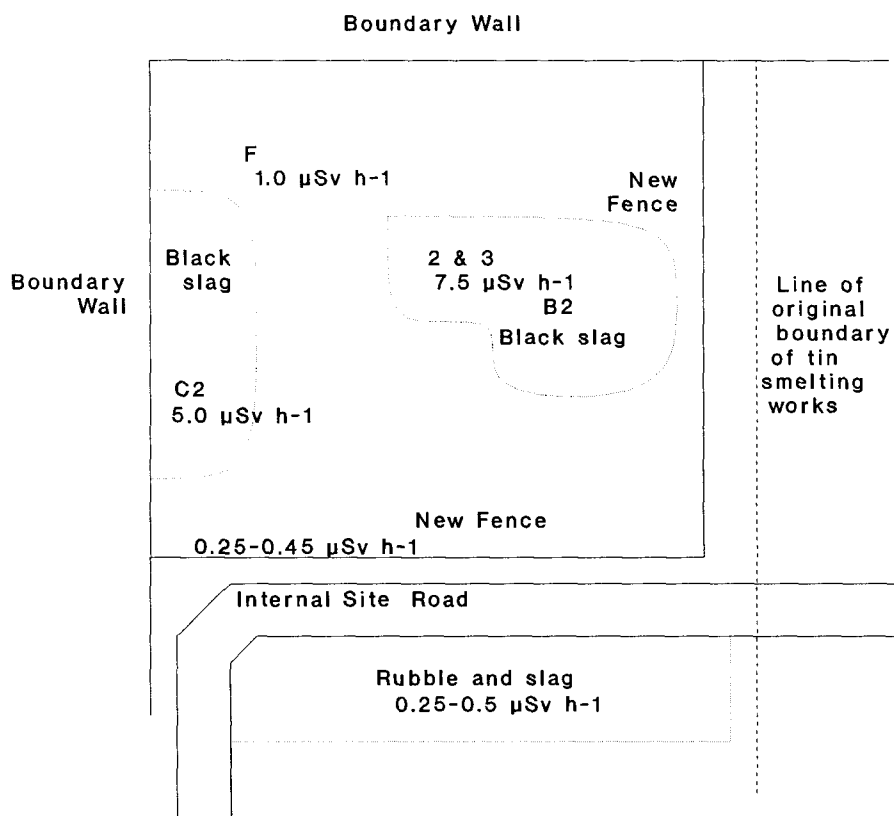
Figure 1: Plan of Affected Area

A more detailed survey was carried out during which a number of samples of various types of material were taken for analysis from different depths with the aid of a mini-excavator. In areas previously inaccessible due to brambles dose rates up to 10 $\mu\text{Sv h}^{-1}$ existed at 1m above the surface. A plan of the site with associated dose rates is shown in fig 1.

Table 1 shows some results of the samples taken from the locations shown in fig 1. Only representative nuclides below and above the radon isotopes need be measured equilibrium levels soon become established after the processing. Values in brackets have been inferred from other measurements; samples were analysed by different laboratories but there was good agreement between them. The slag (samples 2, 3, B(2) and C(2)) is hard vitreous material but around 30% of the ^{220}Rn is lost before it decays to ^{216}Po and around 60% of ^{222}Rn diffuses out.

It was found that the area was covered with slag and rubble to a depth of approximately 1.5m. About 1000m² was found to consist of the more active 'black slag' with about 2500m² of less active 'grey slag' weighing approximately 1900 and 3200 tonnes respectively. The remainder of the material is building rubble.
