# **Implantable cardioverter defibrillator and 50-Hz Magnetic Field exposure in the workplace**

**IRPA 13 Glasgow**

**EDF Medical Studies Department**

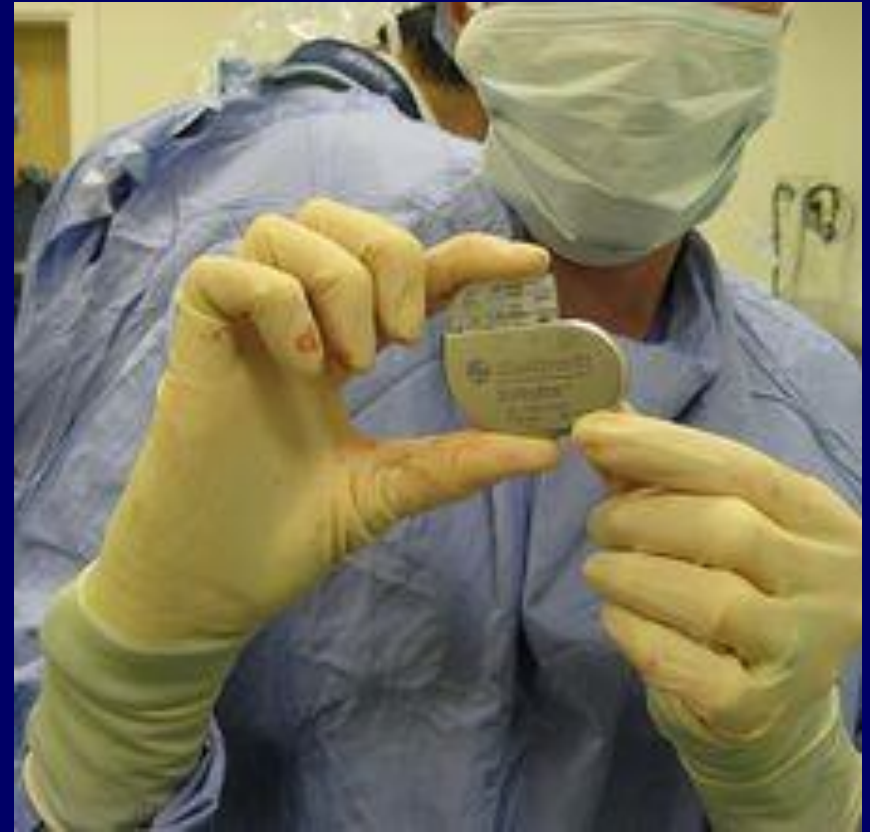
# ICD Components

**With all the functions of a PM and:**

- a high voltage circuit with capacitors ( 500 to 800 volts)
- a special lead to record and pace low voltage, and send high voltage to defibrillate
- a reed magnetic switch to inhibit a new shock in case of recurring shocks

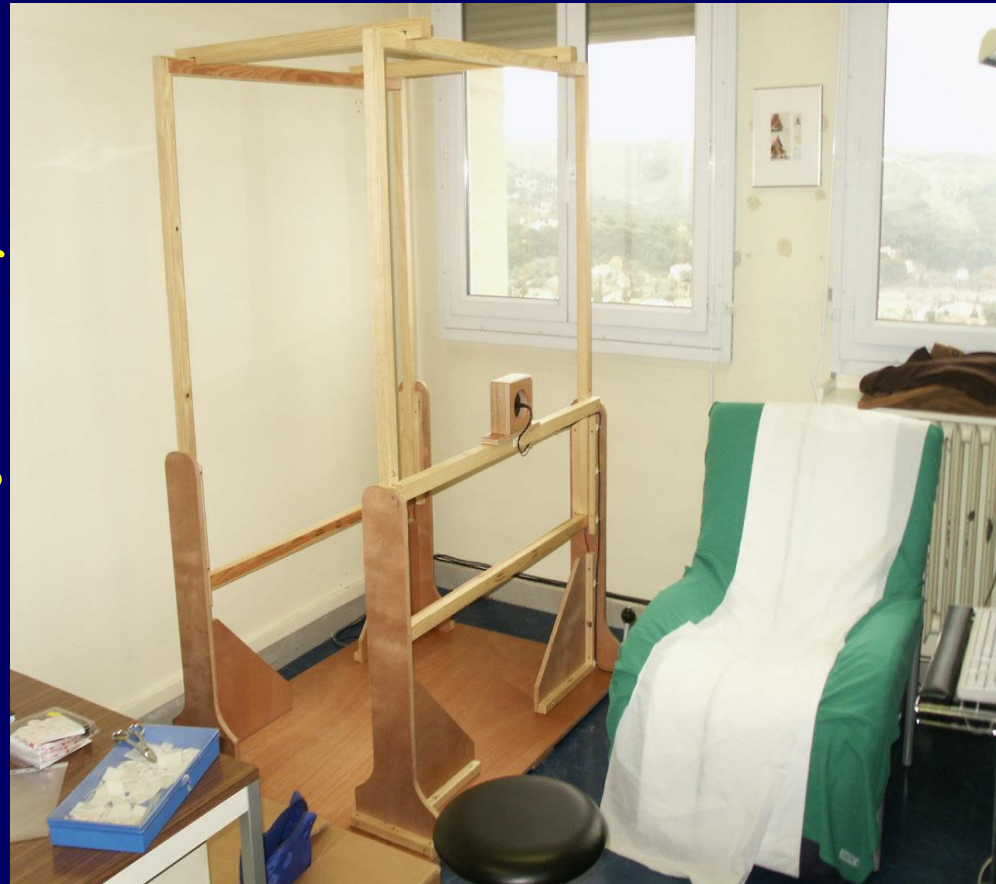
# The exposure system

- The exposure system was made up of a pair of rectangular Helmholtz coils distant from 80 cm, forming a gate.

- 265 patients recently implanted from different manufacturers
- Monitored while passing through, and standing between a system of two coils generating a 50 Hz 100  $\mu$ T magnetic field. (E field:0,10V/m)
- Tests performed with clinically relevant sensing parameters.
- Recordings made with the field on and off for each patient position.
- ECG analyzed in real time, with the physician blinded to the level of the patient's exposure.
- At the end of the tests, the pacemaker programming was controlled.... and reprogrammed..... if necessary.

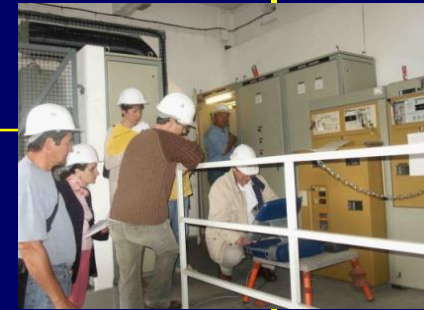
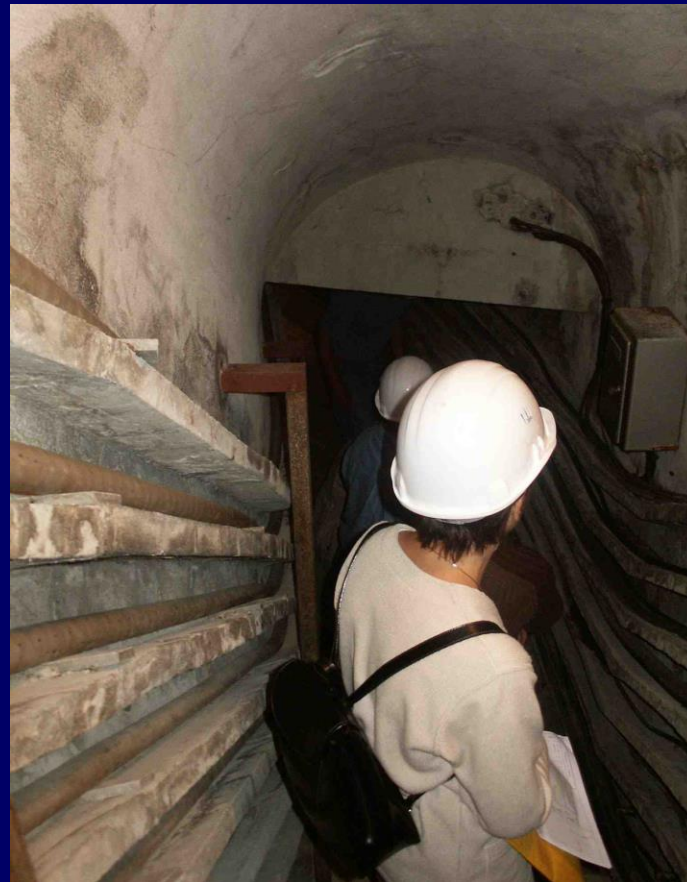
Office computer	Operating position	0,5 $\mu$ T at ICD operating position	ICD control : normal
63kV substation outside	At grid contact	11 $\mu$ T	normal
Bulbe control room	At control cabinet contact	90 $\mu$ T	normal
Machinery room alternator	contact	150 $\mu$ T	normal
Cable gallery	At cables contact	650 $\mu$ T	normal

In the cable gallery:  $650\mu\text{T}$

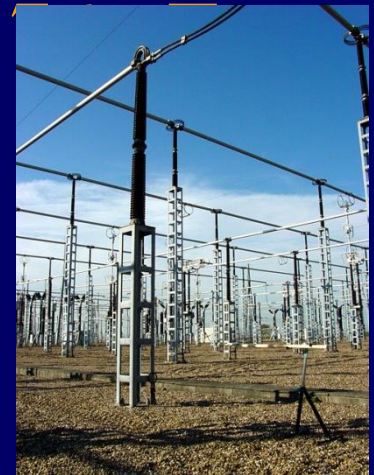
Maintenance technician in a 225 et 400 kV substation (ICD Medtronic)

- ◆ MF max measured in contact with ICD :
- ◆ No dysfunction detected for this ICD
- ◆ Worker declared fit for the job occupied by the occupational physician ,in accordance with the cardiologist

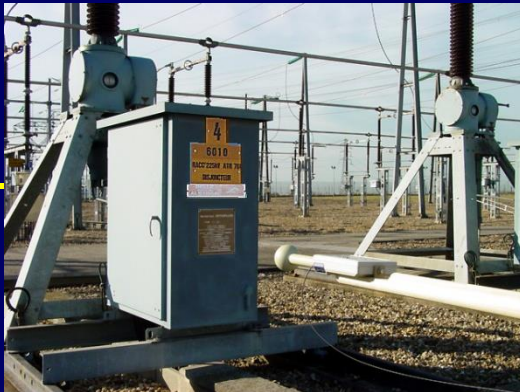
B ( $\mu$ T)	E (kV/m)
Inside the substation relay building	20,4	0,011
Under the 400 kV lines (1700 A)	20,2	5,7
Under an out going lines 400 kV	65,4	12,2
In front of control cubicle 400kV	44,3	4,8
Close to a breaker of the substation 225kV	23	3
Under disconnectors crossing 400kV	76,8	12

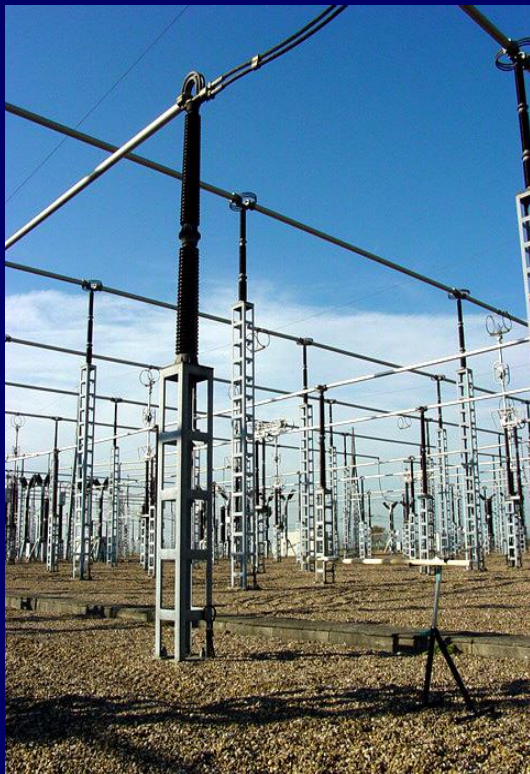
# Any interference in the 400 kV substation
