## Loss of Control of a High Activity Well Logging Source – the Lessons Learned

Health and Safety Executive  
Redgrave Court, Merton Road, Bootle, Merseyside, UK

### Incident

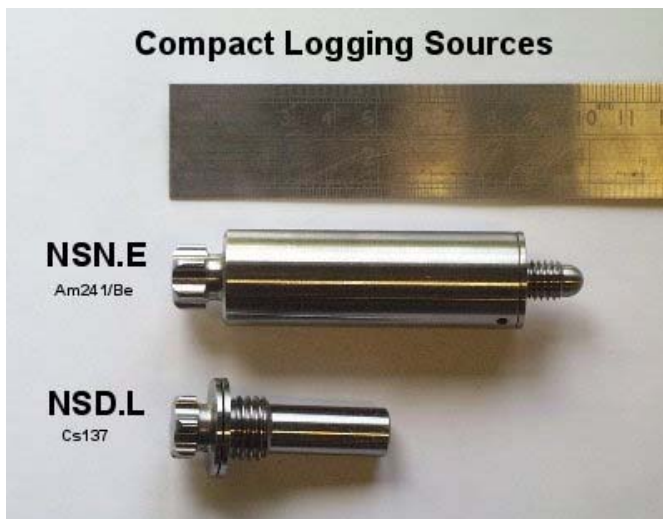
Photograph 1

- Well logging operations using radioactive sources (60 GBq  $^{137}\text{Cs}$  & 590 GBq  $^{241}\text{Am/Be}$ ) was being carried out on a UK offshore drilling rig. ( $^{137}\text{Cs}$  contact dose rate 30 Sv/h)
- High activity  $^{137}\text{Cs}$  source (photograph 1) was dropped onto the drill floor during transfer of the source from a shipping container to a logging tool (photograph 2).
- Source present on the drill floor for 4 to 5 hours until it was discovered and made safe.
- 13 workers potentially exposed in the area.
- Dose reconstructions estimated radiation doses to workers less than the legal dose limits (max 6.8 mSv, extremity 250 mSv).
- Extremely fortunate no worker came into close contact with the source.

- Comprehensive risk assessment required to consider the risks associated with all aspects of the work activity: failure to successfully transfer a source from a shipping container to a logging tool was not considered by the duty holder and adequate control measures were not in place.
- Confirmatory checks of the source location with a radiation monitoring instrument should be fundamental elements of any safe system of work and detailed in the work instructions.
- Work instructions to be clear and concise and disseminated to workers at appropriate intervals.
- Performance audits should be adopted and routinely carried out as these are essential elements of successful health and safety management systems.
