Remediation of a Radium-Contaminated Facility with High Radon Levels

AMEC were contracted to remediate a facility which had legacy Ra-226 contamination resulting from the site's previous use as a luminising works. The work involved monitoring of the facility to establish the extent of the contamination, decontamination of the building fabric, excavation works, characterisation of waste materials and preparation for disposal of arisings.

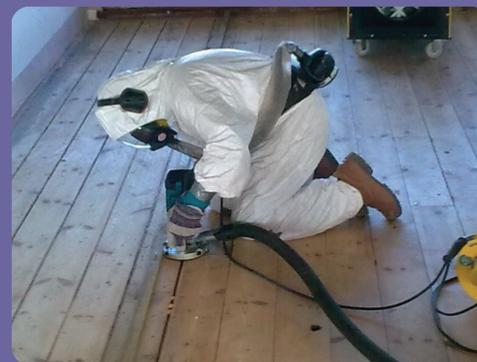
Fig 2: Remediation of wooden flooring

- Excavation work
- Remediation of roof and loft voids
- Remediation and/or removal of wooden wall boards
- Remediation and/or removal of staircases
- Remediation of floors including wooden floorboards and quarry tiles
- Remediation of wooden beams and joists
- Scabbling of walls
- Brick removal from walls
- Investigation works

Various decontamination techniques were employed throughout the works, including novel innovative techniques developed specifically for challenges encountered during the works. These techniques included the routing of tongue and groove joints between floorboards, and the scabbling of difficult to access joists and beams using a reciprocating saw and blade.

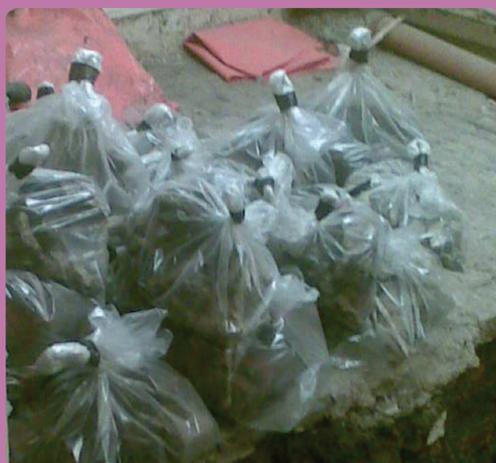
Fig 3: Bagged waste

All clean wastes were subject to clearance monitoring before their removal from the controlled areas 'as soon as reasonably practicable' to minimise the risk of contamination. All contaminated waste arisings were packaged at the workplace and placed in segregated lay-down areas, again to minimise the risk of cross-contamination.

All wastes were double-bagged, characterised and assigned to the agreed disposal route for removal from site.
